**PHASE I RECONNAISSANCE  
SITE CHARACTERIZATION REPORT  
FOR THE  
SILVER CREEK DRAINAGE PROJECT**

**Lewis & Clark County, Montana**

**Olympus Technical Services, Inc.  
765 Colleen  
Helena, Montana 59601**

**February 2003**

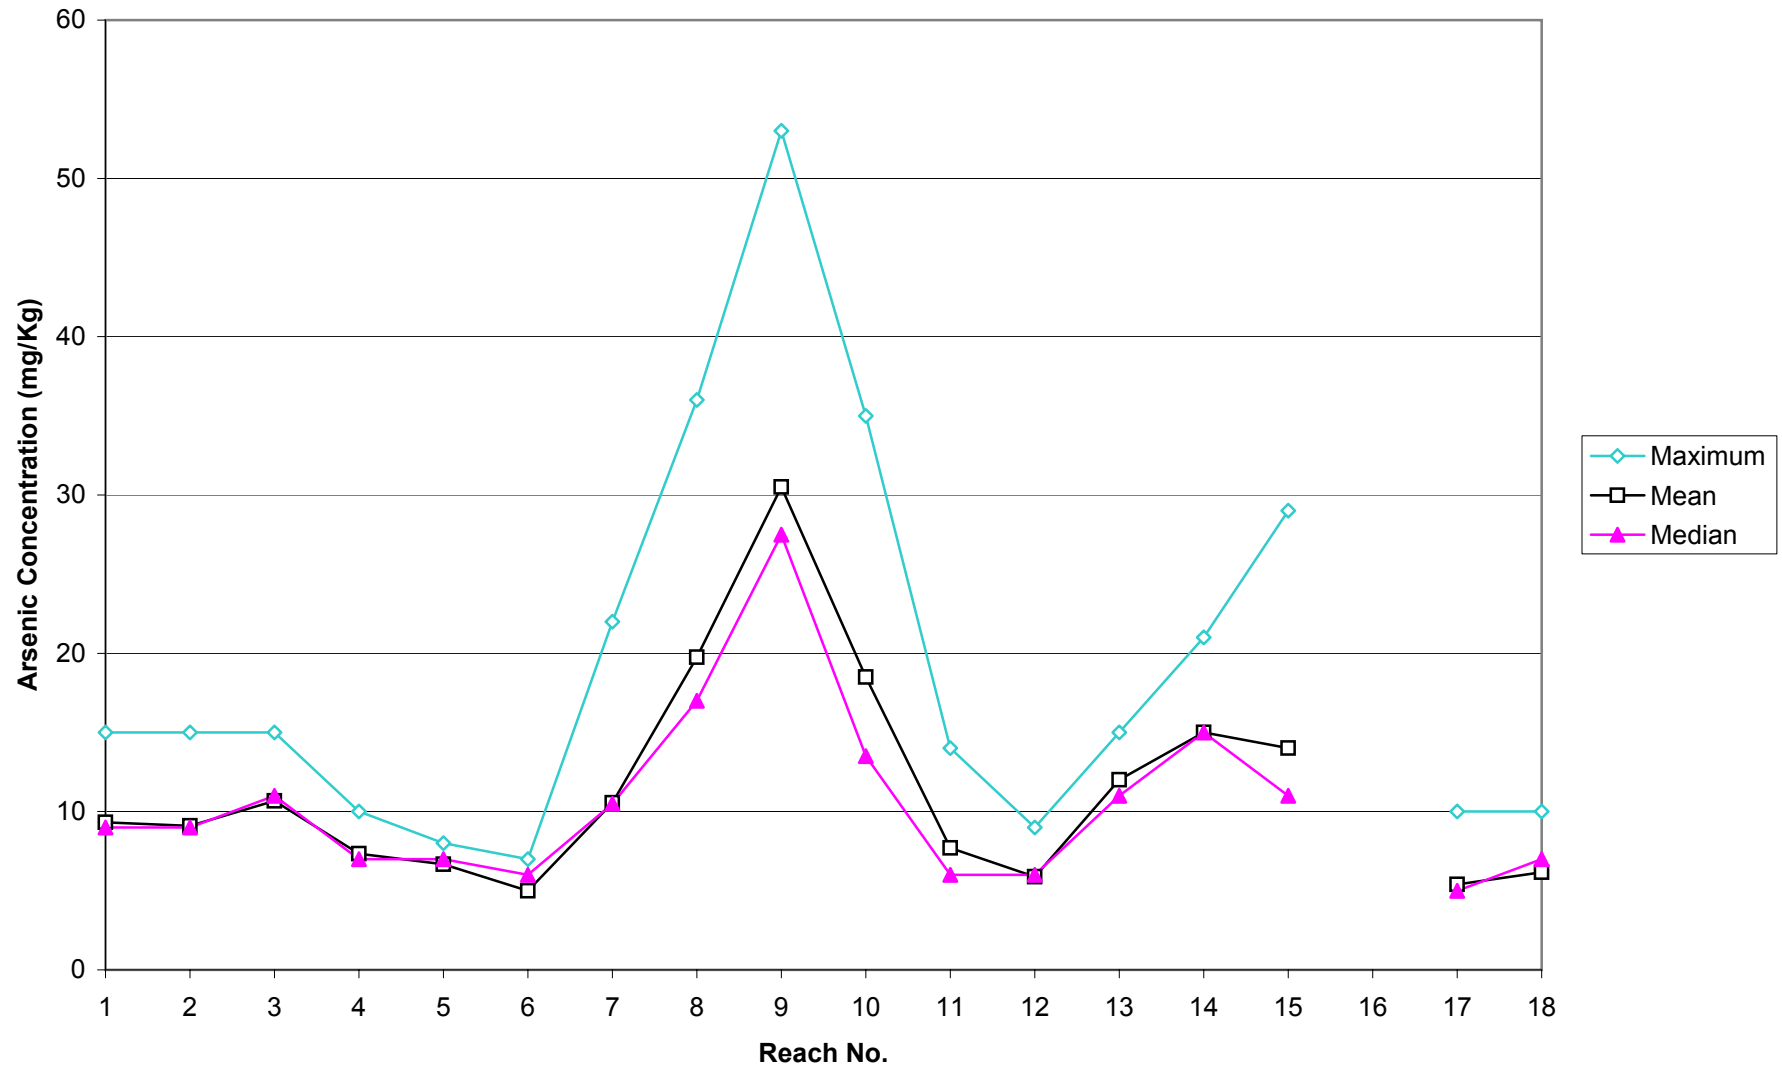
Figure 6-4a. Arsenic in Silver Creek Stream Sediments by Reach

Figure 6-4a shows that the maximum, mean and median arsenic concentrations generally follow similar trends from reach to reach. The lowest maximum, mean and median arsenic concentrations occur in Reach 6, which is located upstream from the Goldsil tailings area. The arsenic concentrations increase below Reach 6 to a maximum in Reach 9 and then decrease. Arsenic concentrations are at another low in Reach 12, which is located south of the largest placer tailings and directly upstream of the pipeline crossing. Arsenic concentrations increase again below Reach 12. Reach 16 was not sampled because no land owner access agreement was in place. Arsenic concentrations decrease again in Reaches 17 and 18.

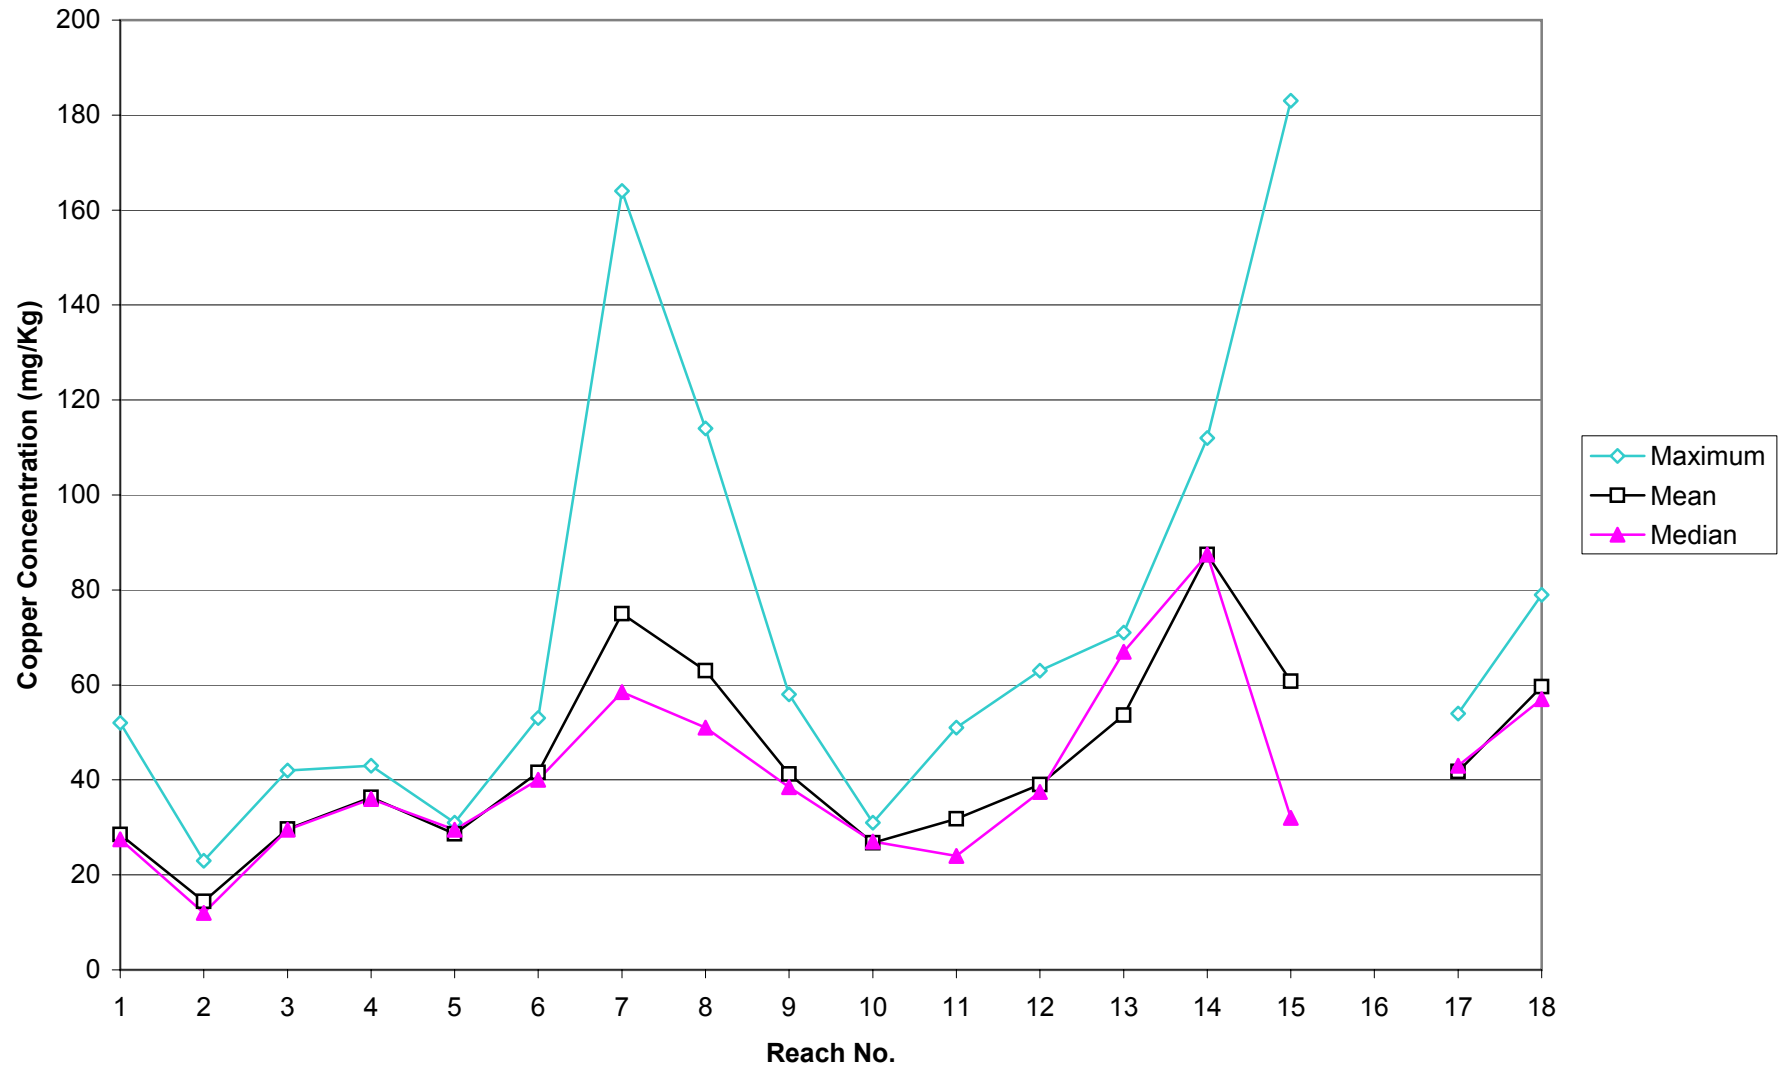
**Figure 6-4b. Copper in Silver Creek Stream Sediments by Reach**

Figure 6-4b shows that the maximum, mean and median copper concentrations follow generally similar trends from reach to reach (with the exception of Reach 15, which shows diverging trends for maximum and mean/median copper). The maximum, mean and median copper concentrations increase sharply below Reach 5 to a peak at Reach 7, then decrease to near minimum values in Reaches 10 and 11. The concentrations increase again below Reach 11 with the highest mean and median values occurring in Reach 14. The largest maximum copper concentration occurs in Reach 15. Copper concentrations show another increasing trend in Reaches 17 and 18.

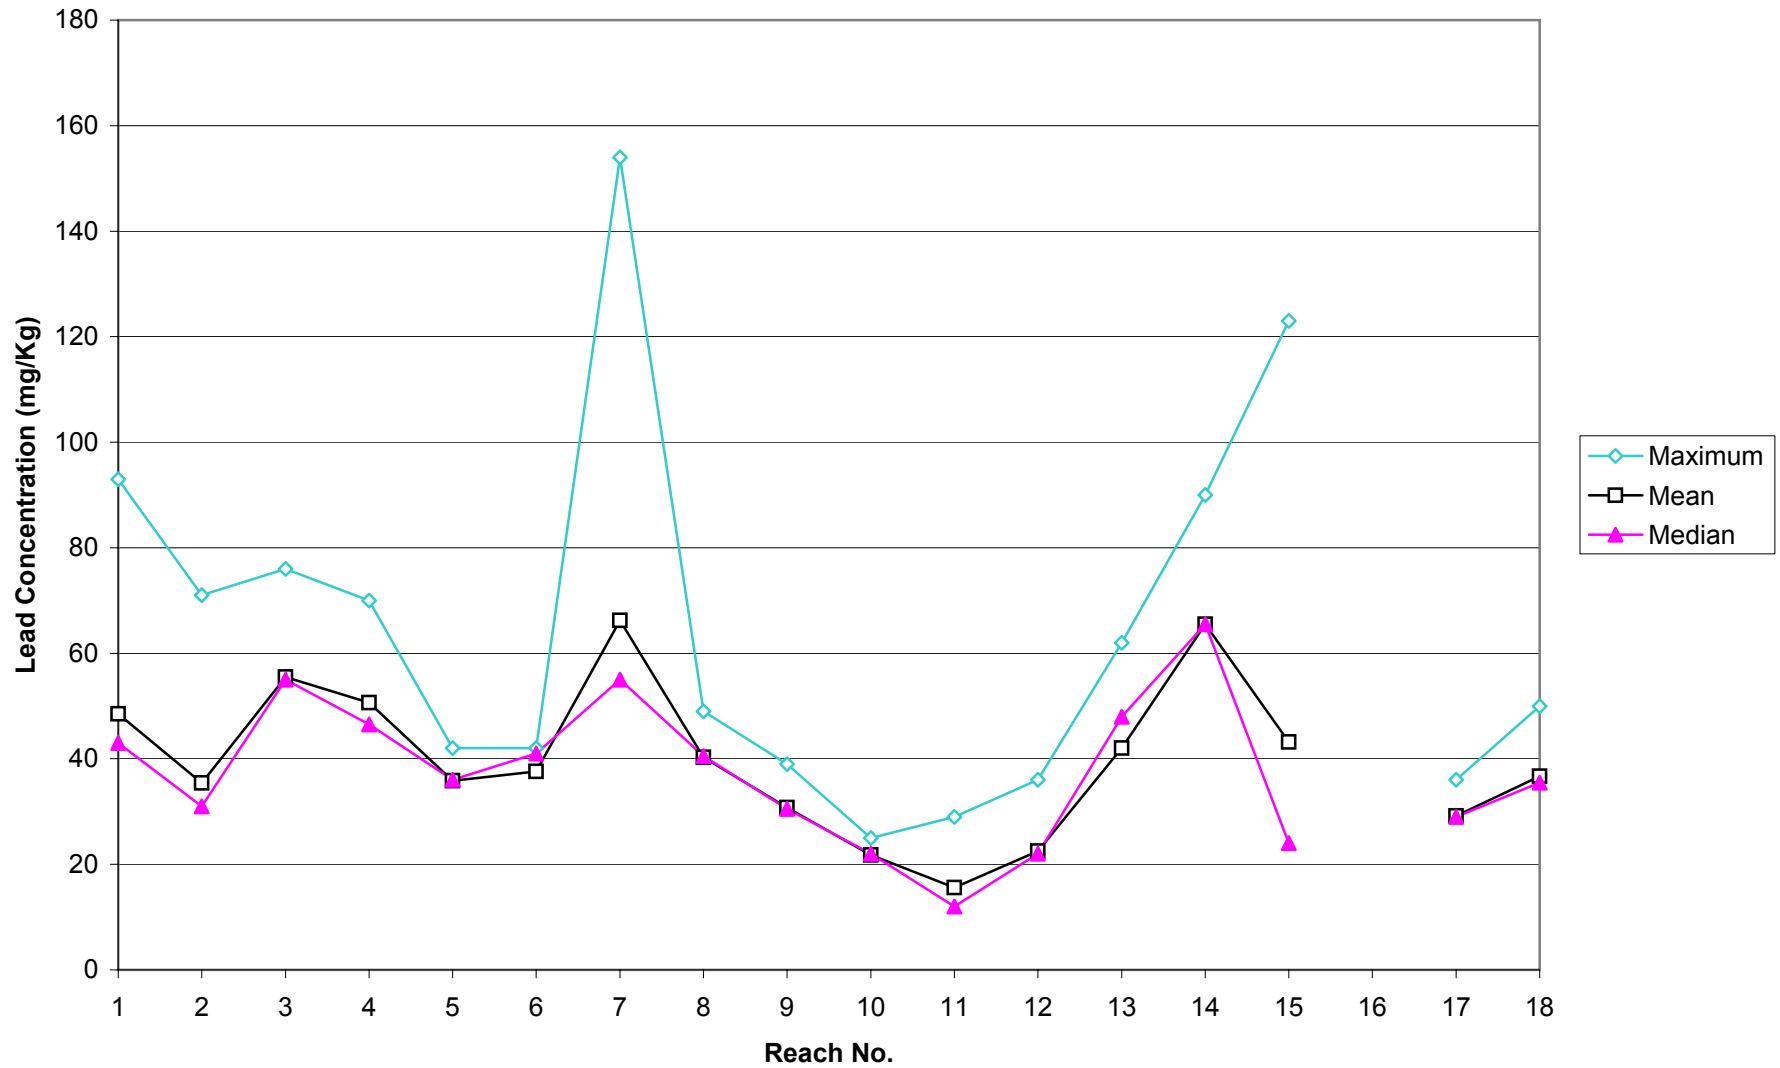
Figure 6-4c. Lead in Silver Creek Stream Sediments by Reach

Figure 6-4c shows that the maximum, mean and median lead concentrations follow generally similar trends from reach to reach (with the exception of Reach 15, which shows diverging trends for maximum and mean/median lead). The maximum, mean and median lead concentrations increase sharply below Reach 6 to a peak at Reach 7, then decrease to minimum values in Reaches 10 and 11. The maximum observed lead concentration occurs in Reach 7. The lead concentrations increase again below Reach 11, with peak mean and median values occurring in Reach 14 that are higher than in Reach 7. The second highest lead concentration occurs in Reach 15. Lead concentrations show another increasing trend in Reaches 17 and 18.

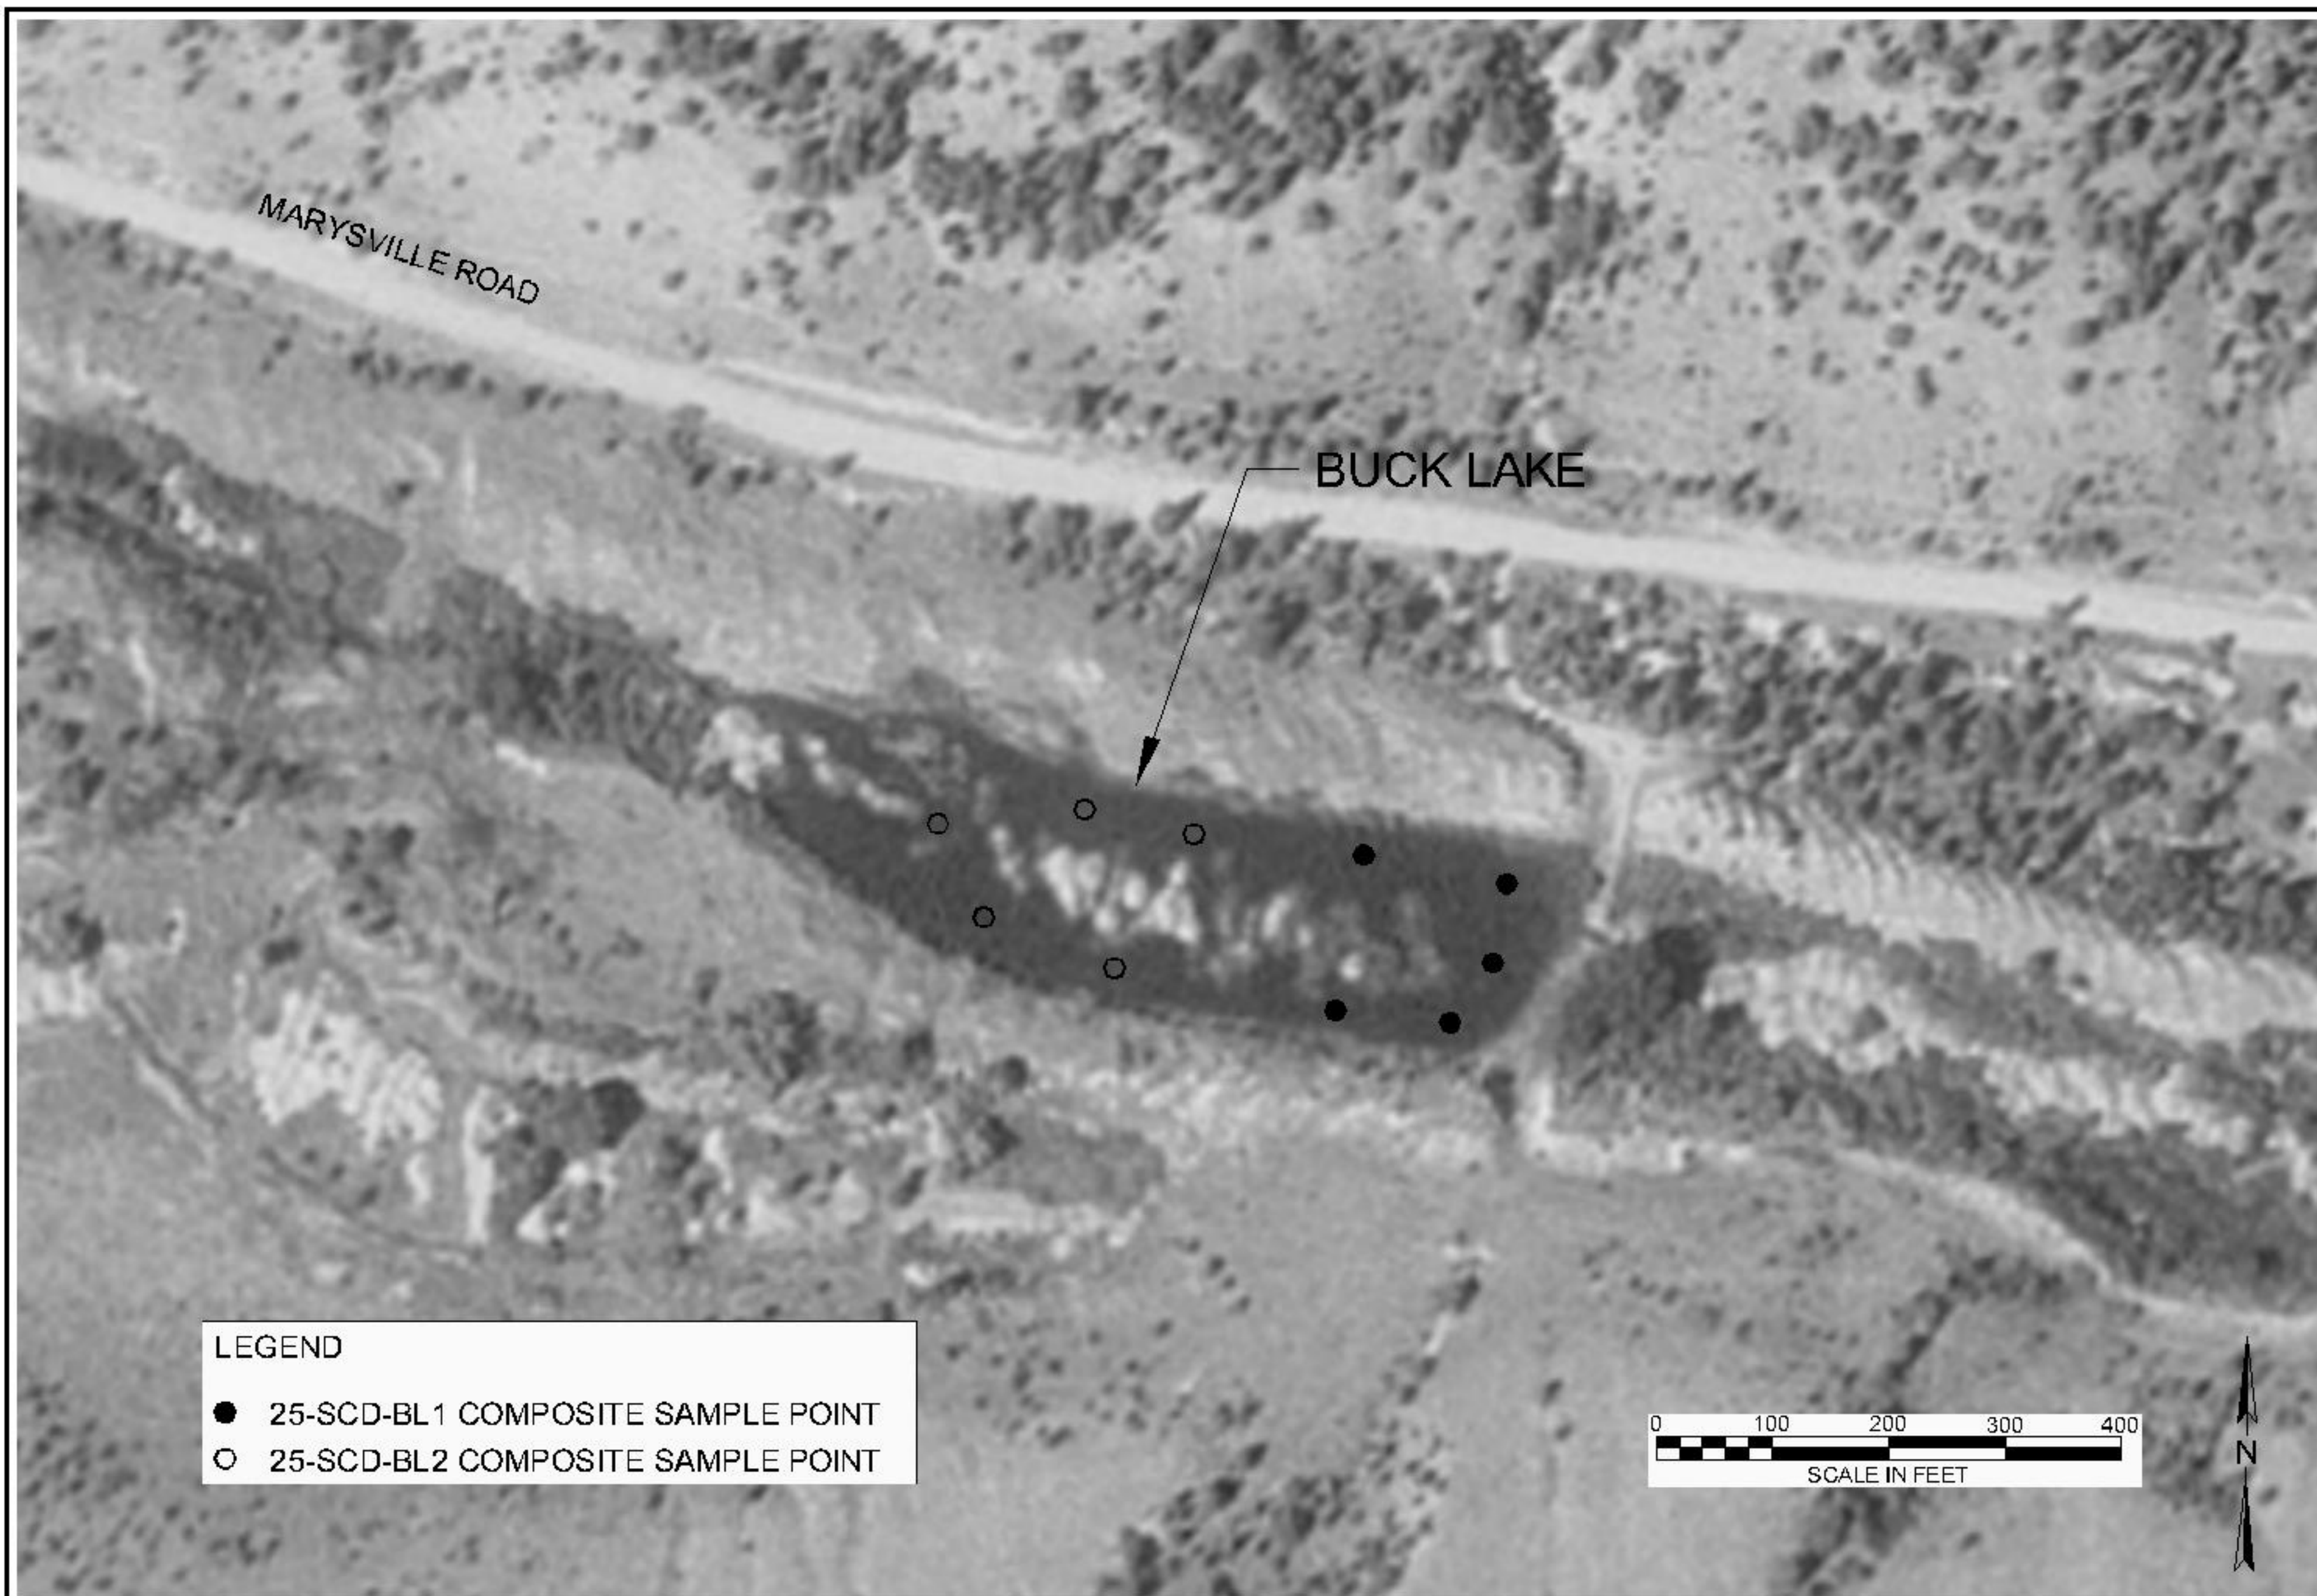
Two composite sediment samples were collected from Buck Lake (Figure 1-7). Sample 25-SCD-BL-1 was collected from the eastern (downstream) half of Buck Lake and sample 25-SCD-BL-2 was collected from the western (upstream) half of Buck Lake. Each sample was composited from five discreet sediment samples collected from the lake bottom. The composite points are shown on Figure 6-7. The discreet samples were collected by driving a two-inch PVC pipe into the lake bottom to obtain a core sample.

The arsenic (5 and 6 mg/Kg), copper (26 and 49 mg/Kg), lead (24 and 26 mg/Kg), mercury (9 and 12 mg/Kg) and zinc (53 and 66 mg/Kg) concentrations are within the range of concentrations found for the elements in the stream sediment samples. Cadmium concentrations were less than the laboratory detection limits.

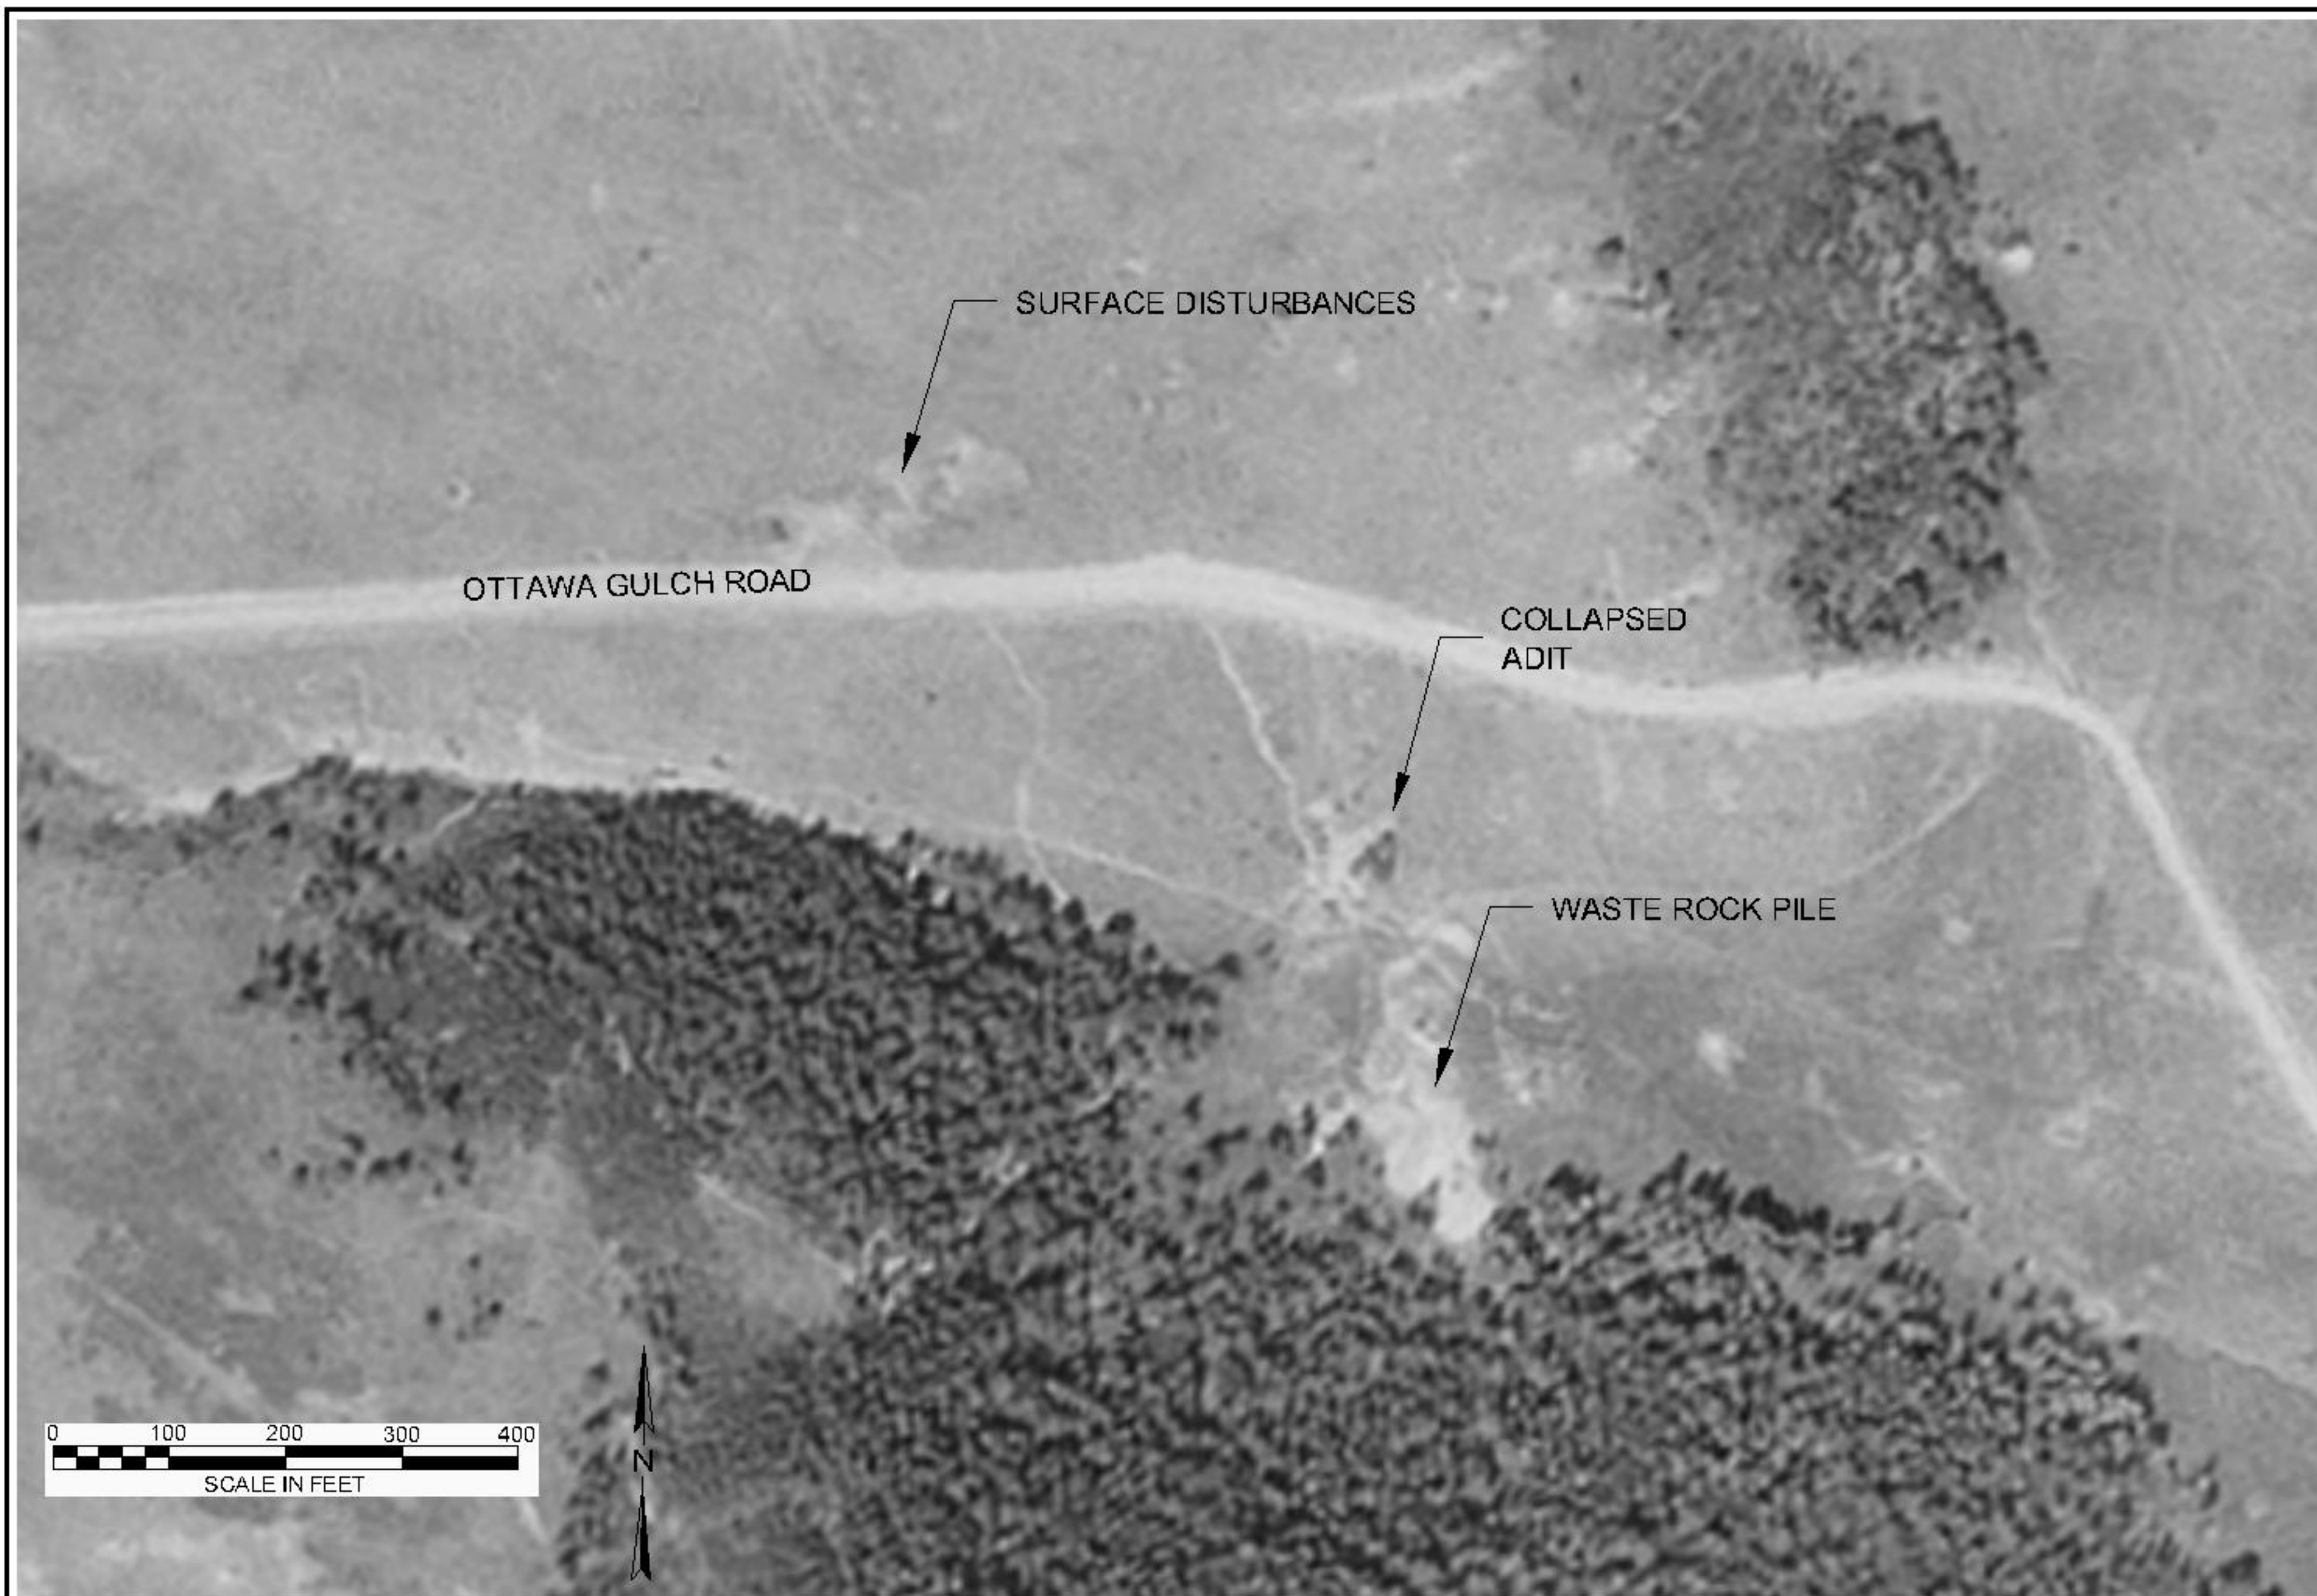
Olympus completed a reconnaissance of the Shannon Mine area in November 2002. At the time of the reconnaissance, the ground was mostly clear; however, there were snow drifts covering portions of the site. The site was located in the field according to the location shown on the USGS Greenhorn Mountain 7.5 minute Quadrangle map. The map shows the mine site location to be just north of the Ottawa Gulch road. Olympus observed an area with several small surface disturbances (Figure 6-8), all of which are less than 15 feet by 15 feet in surface area. Two of these disturbances appeared to be small excavations; however, both were filled with drifted snow so the depth could not be evaluated. It is possible that the surface disturbances could be shallow prospect pits or collapsed shafts.
